**PORINGLAND
INTEGRATED URBAN
DRAINAGE STRATEGY**

**SUPPLEMENTARY
GROUNDWATER
DRAINAGE REPORT**

REPORT REF: 8807/02/SH/05-08/2237

CLIENT: South Norfolk Council

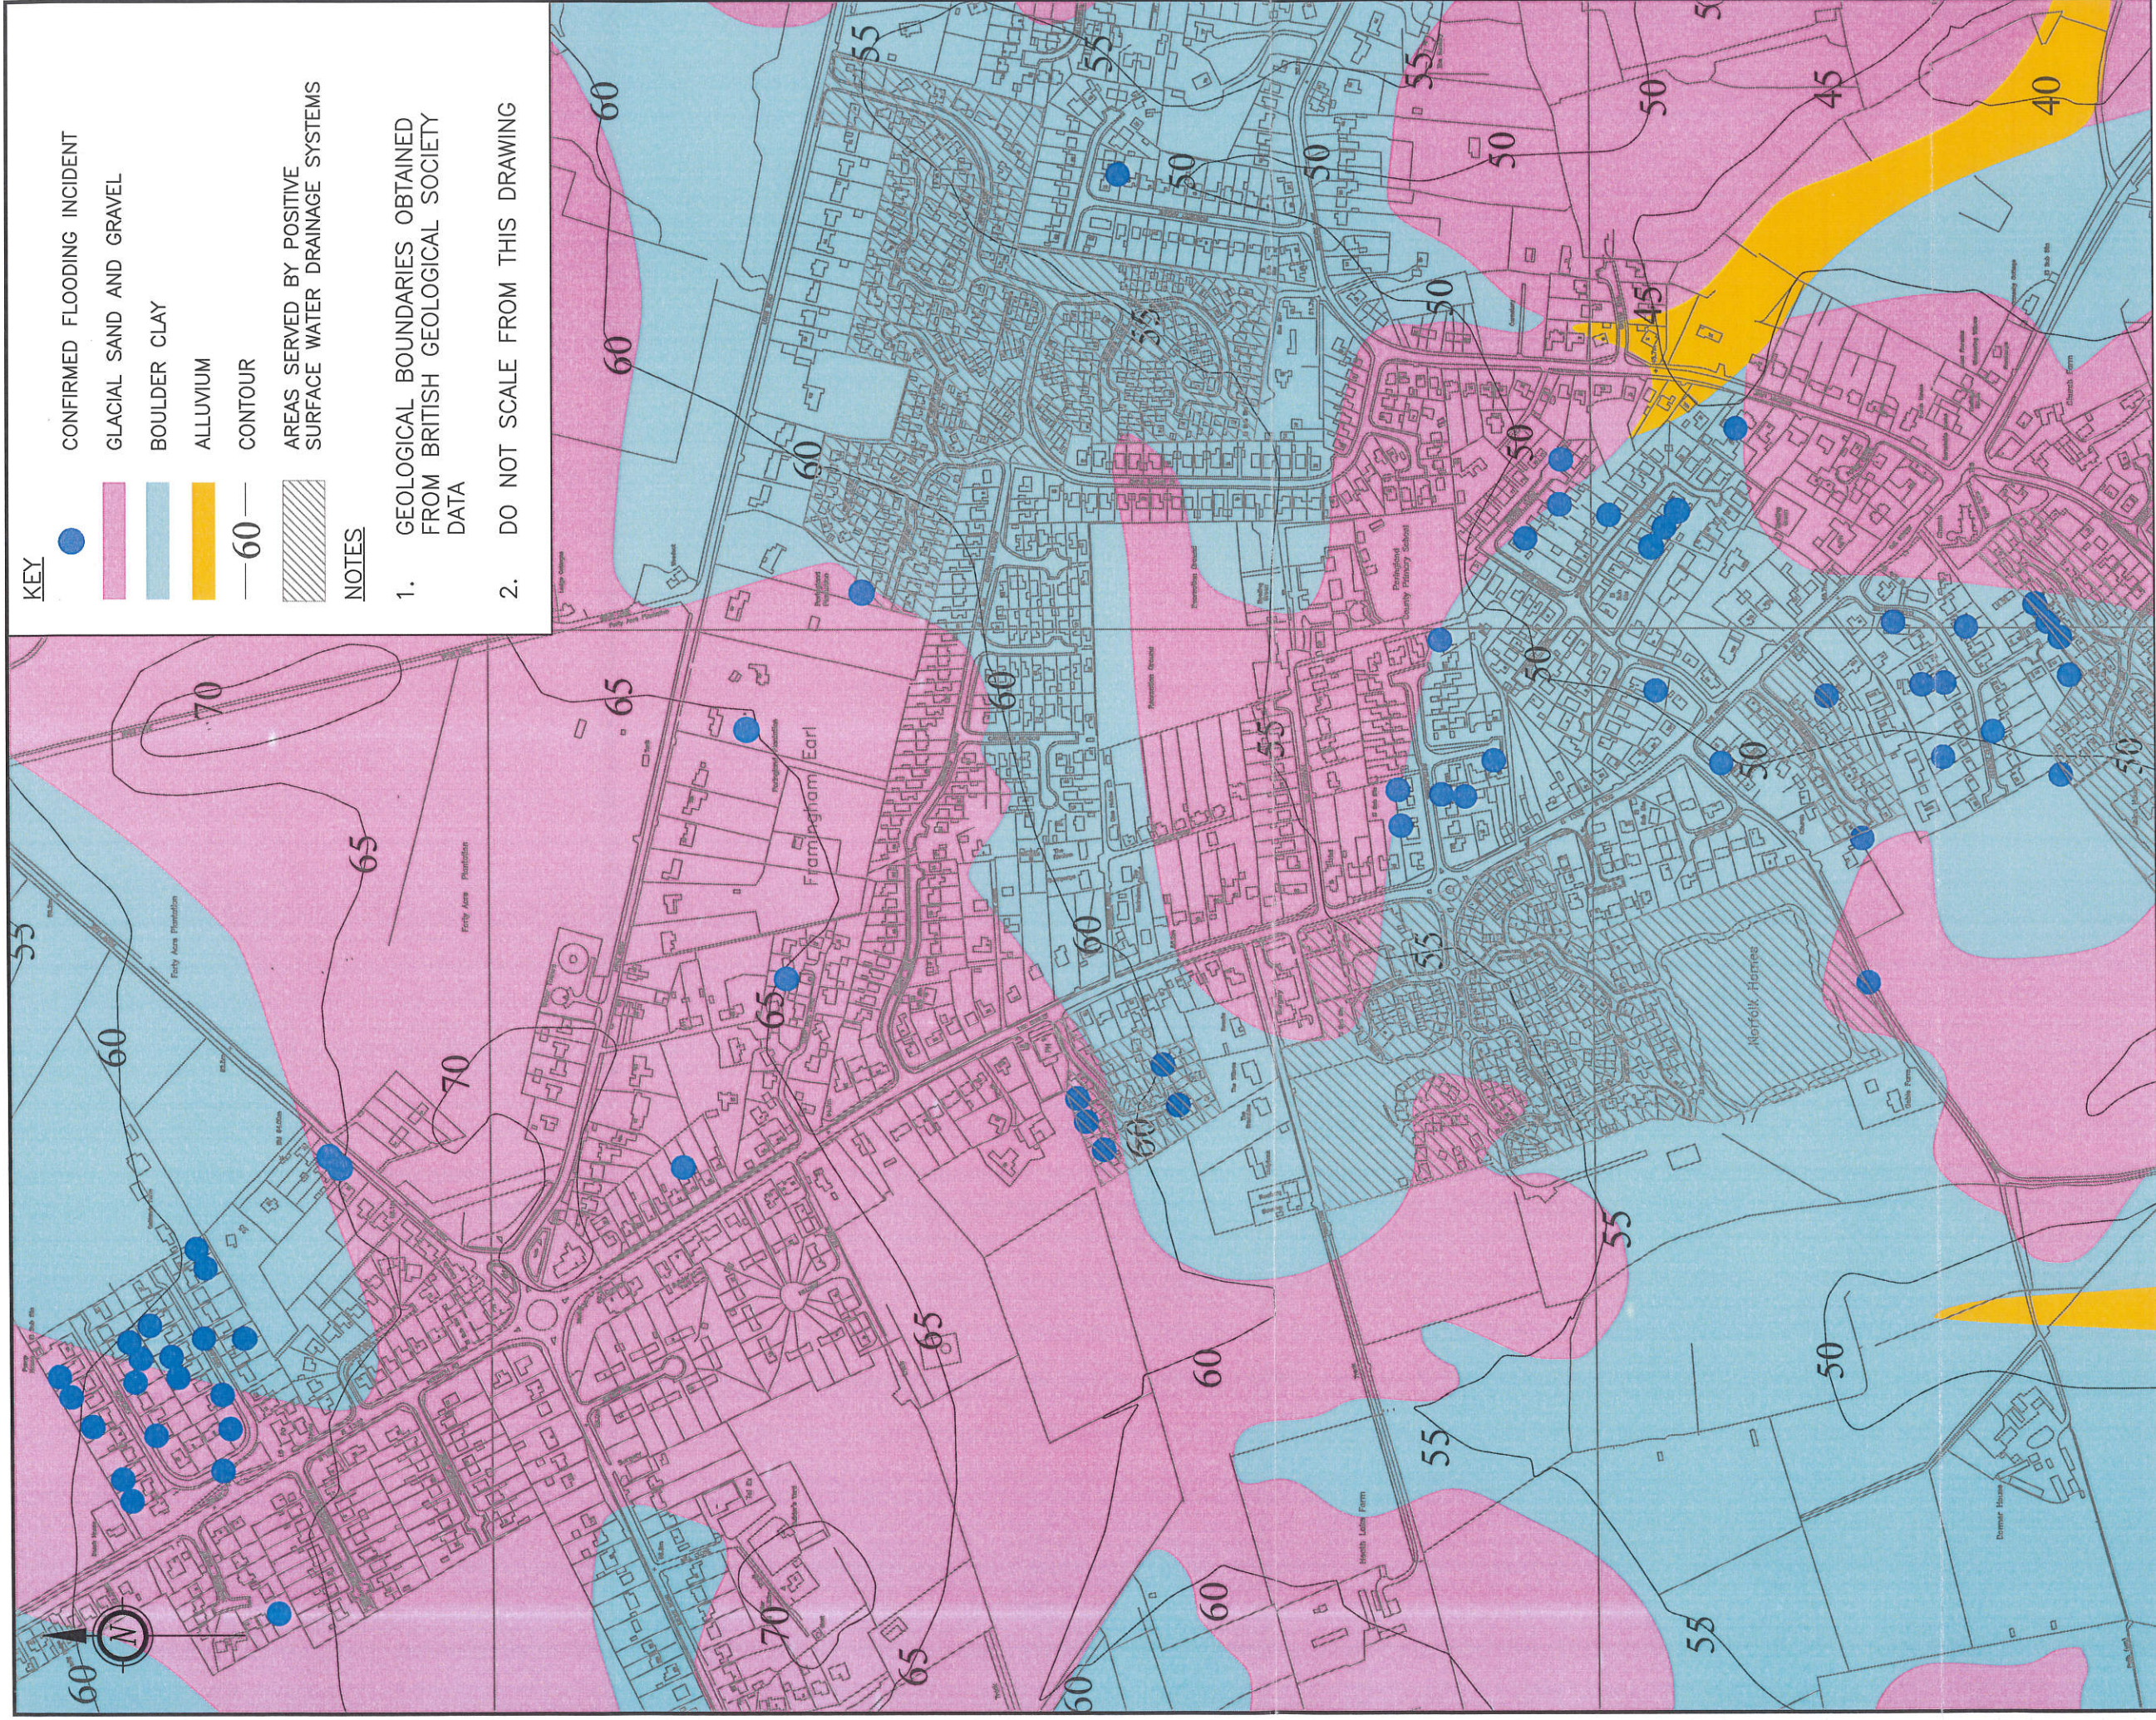
| 8807/21/05A | FLOODING INCIDENTS, CONTOURS AND BGS GEOLOGICAL FEATURES |

- 5.2 The schedule has been reviewed and those flooding incidents which seem to be due to ground or surface water have been shown on plan number 8807/21/05A. In addition to a small number of isolated or individual flooding problems, the plan clearly identifies six clusters of flooding problems across the study area, in Oaklands, Spruce Crescent, Springfield, Malten Close, Hadden Close, and Church Close.

- 5.3 The flooding incidents in the Oaklands area of Framingham Earl seem to straddle the interface between the edge of the Glacial Sands and Gravels and the underlying Chalky Boulder Clay. This suggests that the flooding problems in these areas may be groundwater related. A review of the historic maps indicates that the development was constructed across three former fields. Survey work undertaken by Anglia Survey and Design indicates that the previous field drainage ditches have been infilled contributing to the surface water flooding problems. Recent work undertaken by South Norfolk Council to identify and open up former ditches in this part of the study area may assist in lowering groundwater levels and reducing future flooding problems.

- 5.5 The reported flooding incidents in Spruce Crescent are located at the edge of the Glacial Sands and Gravels. However, it is likely that the Chalky Boulder Clay will lie fairly close to the surface under this site. The properties have been constructed with a positive surface water drainage system which drains to a watercourse to the west of the development. In view of this, the most likely cause of the flooding at this location is groundwater. Comparison with the historic maps of the area shows that the site of this development originally comprised several small fields. The reported flooding incidents all lie close to former field boundaries and therefore it is likely that the problems are caused by either infilled ditches or the removal of former hedges.

- 5.6 There is a broad scatter of flooding incidents along the likely interface between Glacial Sands and Gravels and the Chalky Boulder Clay in the area which includes Springfield, Malten Close and Hadden Close. The name Springfield possibly predates the development and is likely to be indicative of wet soil conditions. Malten Close and Hadden Close lie in the shallow valley of a watercourse and as a result could expect to have a high natural water table. Both of these locations would be vulnerable to flooding due to groundwater seepage. Recent flooding in Malten Close seems to have been aggravated by defective soakaways and the development of adjacent land which has raised soil levels to the rear of numbers 6 to 14

- 5.7 The historic maps show that the land occupied by Church Close is crossed by a field boundary and is bordered to the west and south by a drain (watercourse). This watercourse flows in a southerly direction along the western boundary of Church Close before turning east between Church Close and Alder Close. It is no longer clear on the ground where the watercourse runs after this point though it is likely to flow towards Shottesham Road to the west of the Churchyard. Over half of the reported flooding incidents in Church Close coincide with the route of the drain and the line of the former field boundary which crosses the site. The remaining flooding incidents in the northern part of Church Close are possibly due to defective soakaways within the clay subsoil.
